Truck Stop Inc.

Kevin Gramentz  
6351 Brighton Ave SE  
Montrose, MN 55363  
daburb@gmail.com  
612.242.9925  
Restoration Parts for 1947-2007 Chevrolet/GMC Trucks

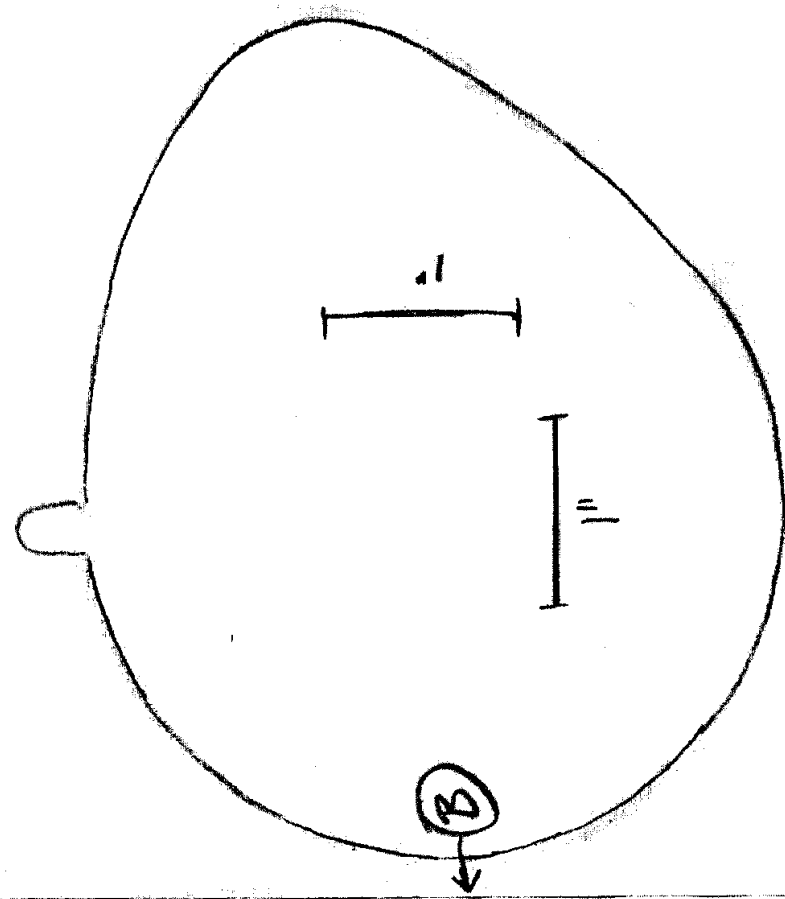
Looks like  $3\frac{5}{8}$ " DIAM  
Paper Tucked @ top of sheet & @ bottom of dash.  
Who about  $3\frac{1}{32}$ " away @ middle (B) so it should  
be just under  $\frac{3}{8}$ " -  $\frac{5}{16}$ "
